2018 Kerala Floods

Learnings from the Post-Disaster Damage Survey

July 2020

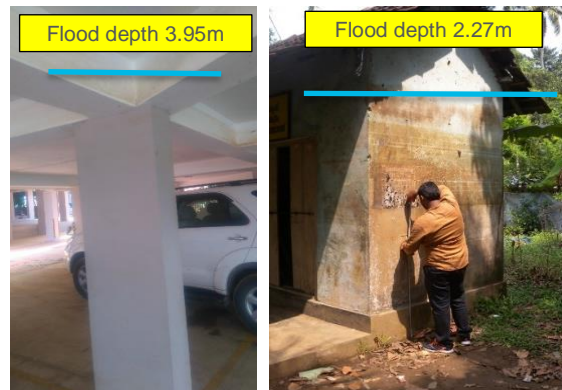
Figure 3. High water marks on residential buildings flooded from Periyar river waters

Residential areas in the vicinity of the Ernakulam district and located close to the Periyar River, such as Desam, Kalady, Parambavoor, Kothamangalam, Chendamangalam and Puthenvelikara, were also inundated with water depths of 1.5 to 2 meters (Figure 3). The buildings suffered serious contents damage, consisting mostly of furniture and major appliances.

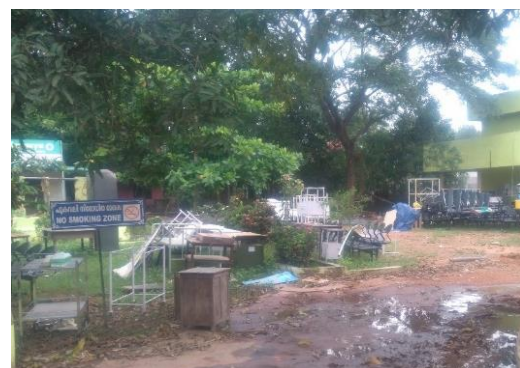
Figure 4. Damaged medical equipment outside a government hospital in Chalakydy. (Source: AIR)

each movie theatre; hospitals were affected in similar way. Figure 4 shows damaged furniture in a government hospital in Chalakudy.

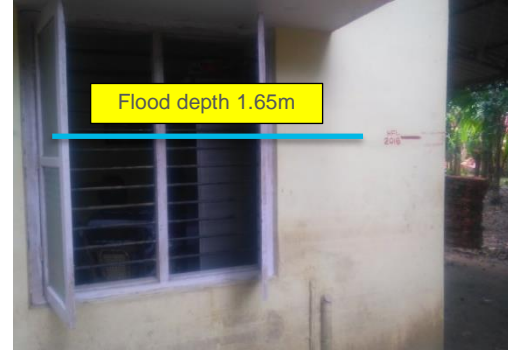
Figure 5. High water marks at a fuel station in Ranni (left) and at the Pandanad Panchayat Office (right)

Kuttor, Thirumoolapuram and Vallamkulam villages on the banks of Manimala River, a tributary of Pamba River, were submerged under 2 meters of floodwaters. According to the local panchayat office, almost all the commercial and residential buildings were under water for three to five days. The nature of the building damage in this area was also related to electrical, generator, and plumbing systems as well as contents. Figure 5 shows one of the flooded fuel stations in Ranni and a flooded Panchayat building in Pandanad village.

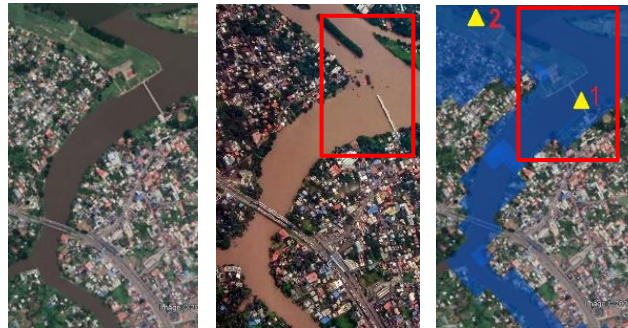
Figure 6. Aerial image of Aluva city on the banks of Periyar river (left); flood extents on 15th Aug (center) and AIR 100-yr extents in blue on aerial image (right)

The observed event footprint from remotely sensed and aerial imagery as well as flood depth information collated from the post-event survey were compared against AIR's 100-year flood hazard layer. Figure 6 shows an example: the left-hand panel is an aerial view of flood extents for the city of Aluva located on the banks of Periyar River with the submerged area outlined in red wherein the area inside the red square box is seen to be submerged in both the aerial event extent and the modeled 100-year extent. The right-

hand panel also shows two points where flood depths were measured by the survey team. These same two points have been shown on the scatterplot (Figure 8) and both the observed depths are in line with the modeled depths.

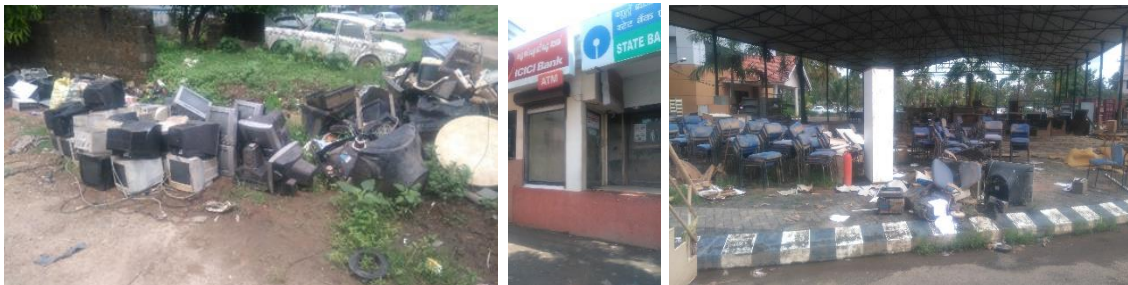
Figure 9. Electronic equipment and vehicles damaged in the floods (left), a couple of damaged ATM kiosks (center), and furniture damaged in a college (right)

AIR observed that nonstructural components damage such as contents and business interruption were more common. In Kerala, buildings are usually constructed with brick and mortar, which are not directly prone to damage by floodwaters; however, in some cases excess buildup of water on one side of concrete walls as in the case of boundary or flood retaining walls have caused the structure to fail. Contents losses were a common occurrence both in commercial and residential properties. Facilities storing large quantities of goods were particularly vulnerable. This included places such as supermarkets, warehouses, and shops. Articles that were damaged in the floodwaters included electronic equipment, medical equipment, stationery, clothes, food items, and furniture (Figure 9). When water submerged ATM kiosks, it damaged both the internal machinery and the currency stored inside. In addition to such contents losses, costs associated with cleaning after the deluge were also significant. Floodwaters usually are heavily laden with silt and other debris, which gets deposited and needs to be cleaned once the waters recede. Growth of mold and fungus is another phenomenon common in warm humid places where floodwaters stagnate for longer duration. In such cases, mold formed on the walls and wooden structures, affecting aesthetics and health, and structural aspects of the place often needed repairs.
